NOAA HAZMAT Scientific Support Field Report

29 February 2004

## Avondale Shipyard Site Follow-up Visit

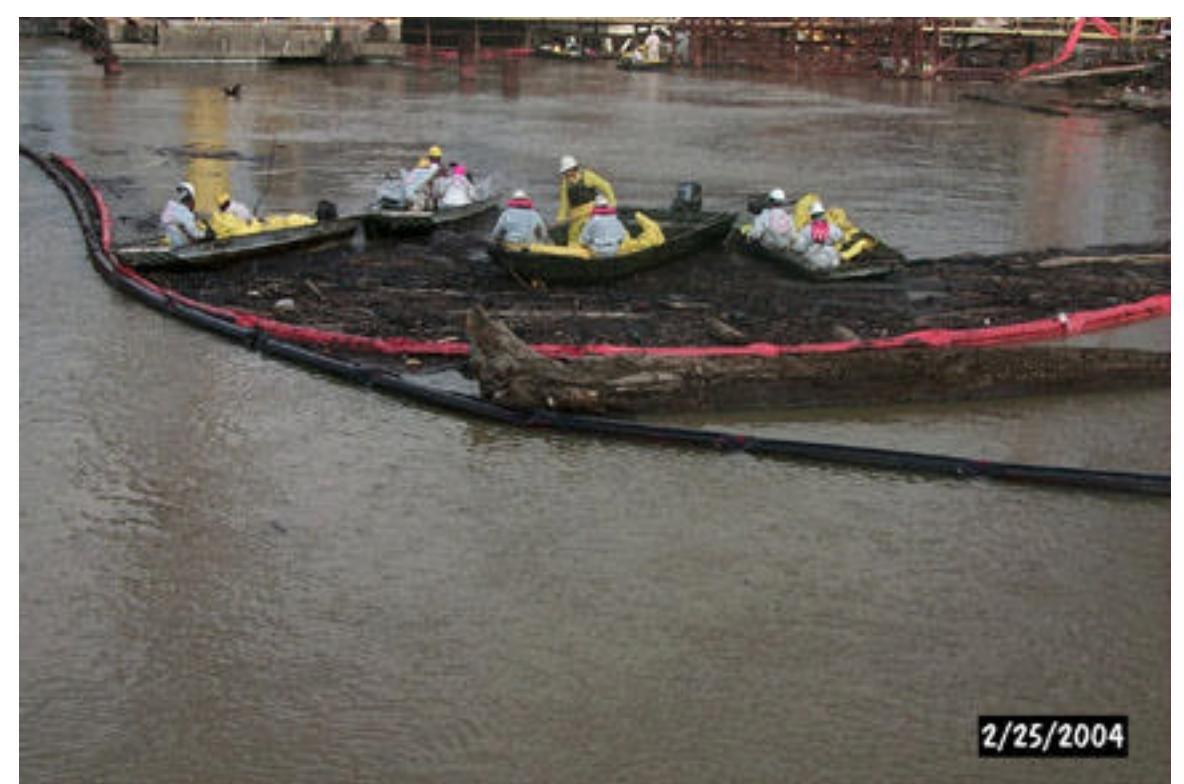
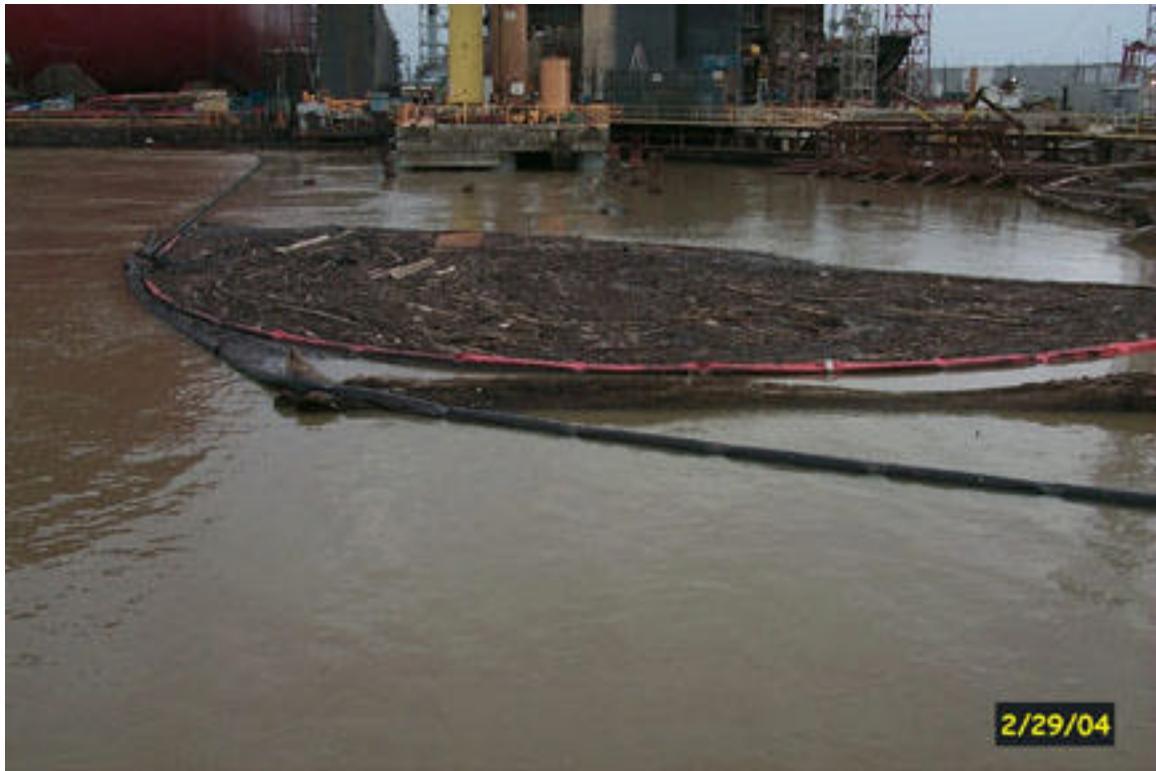
Photographs 1 and 2 compare the raft of debris on 25 and 29 February. The amount of debris has actually increased. This site is a natural collection area for debris and trash from the Mississippi River. Note the large metal container that has recently floated in and entrained under the boom.

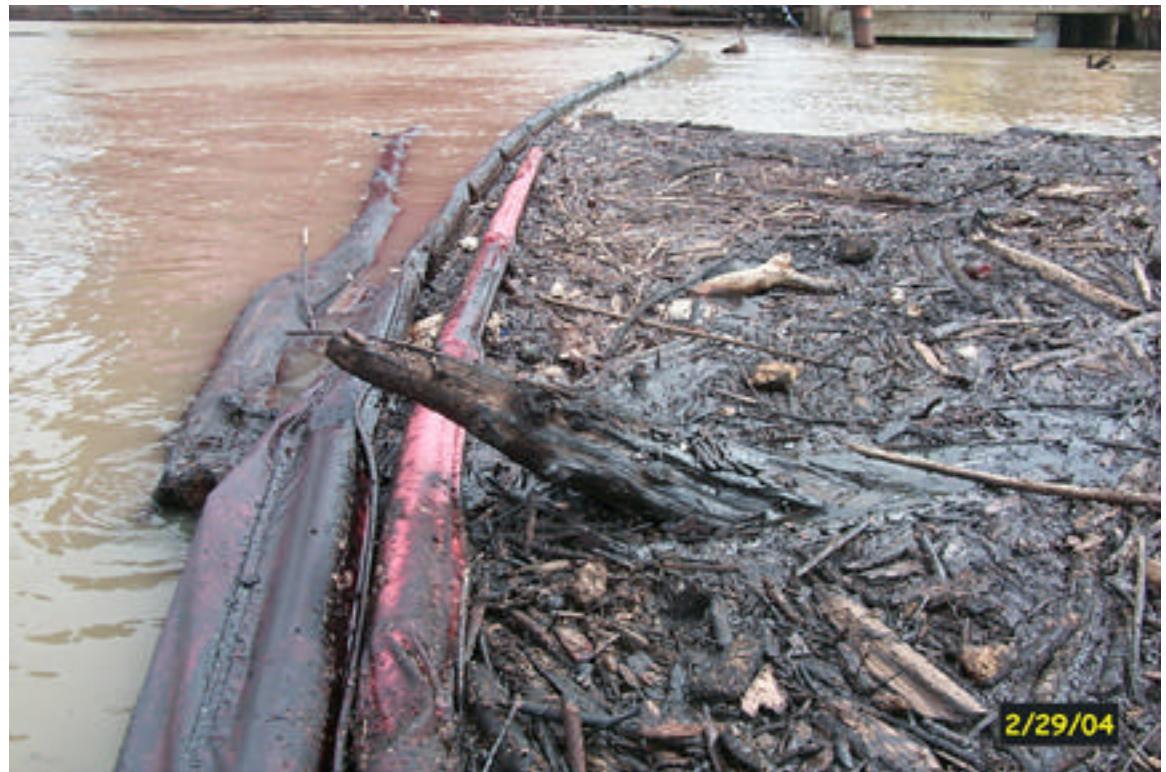
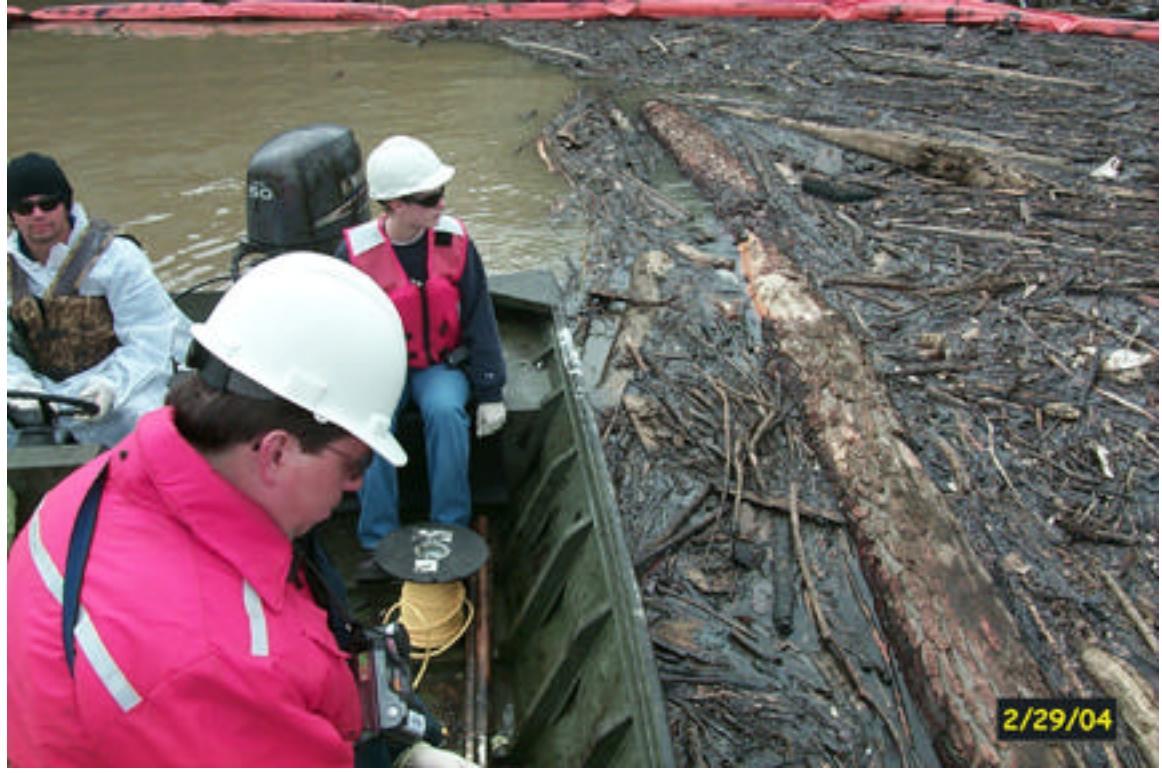
Photographs 3 and 4 are additional photographs of the debris. While very small specs of oil (or an oil-like substance) and some stain could be removed by swishing sorbent pads in direct contact with debris, very little oil was actually recovered. Again, the booms were the greatest source of oil present and needed to be removed. The dark areas in the photographs may appear to be oil, but is primarily the wood itself and accumulations of dark colored wood chips and other organic material. No free oil was observed.

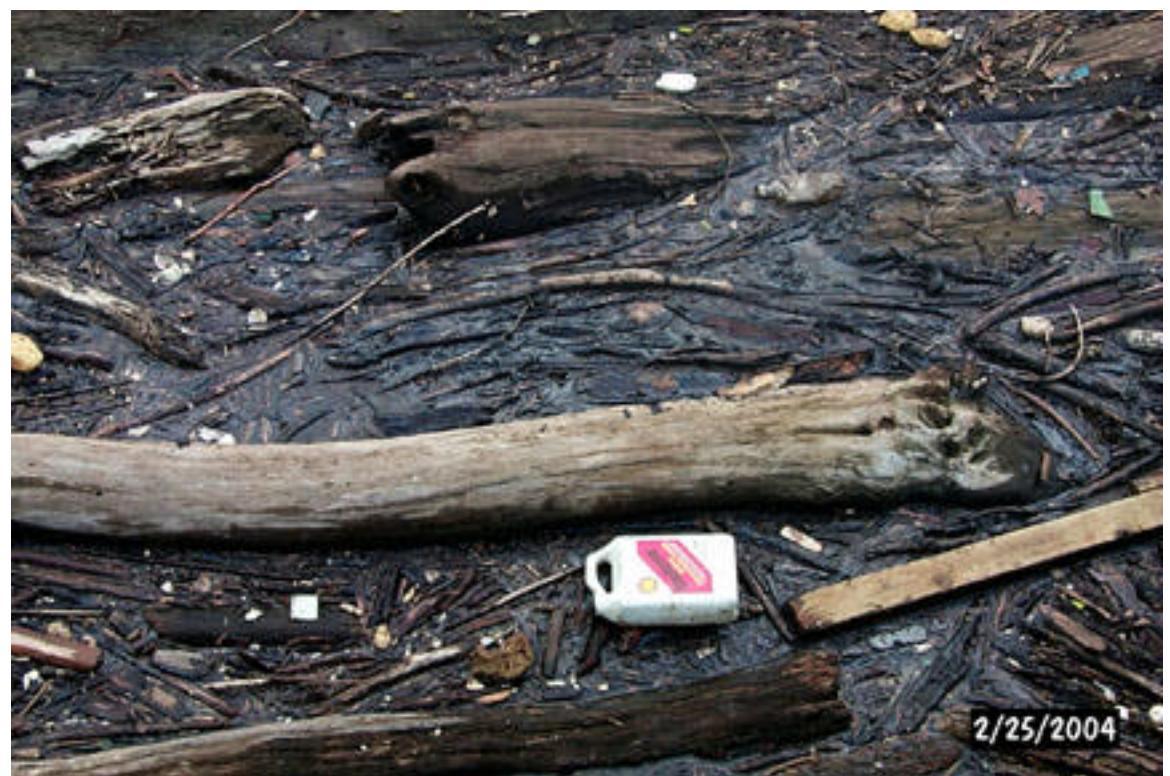
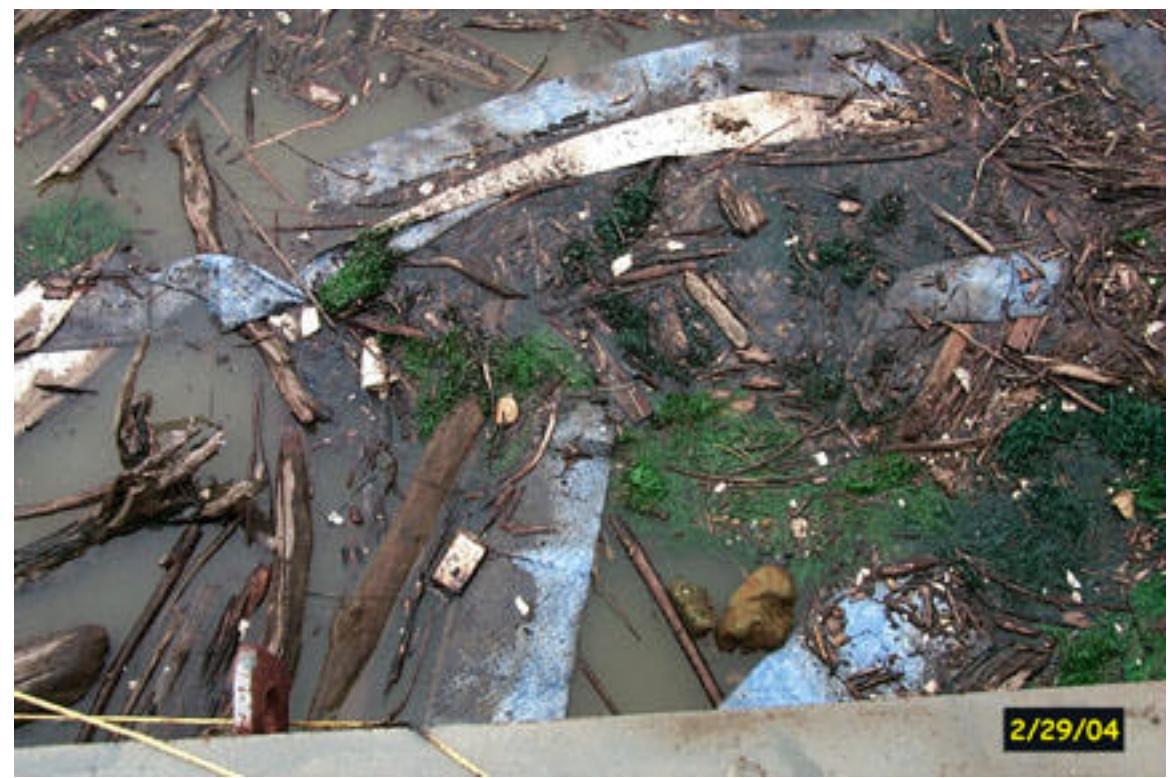
Photographs 5 and 6 compare the small pocket of oily residue observed on 25 February with the deployed snare and sweep. After four days, very little oil stain was observed on the sorbents. Most of the brown discoloration is organic (and mud) and not oil.

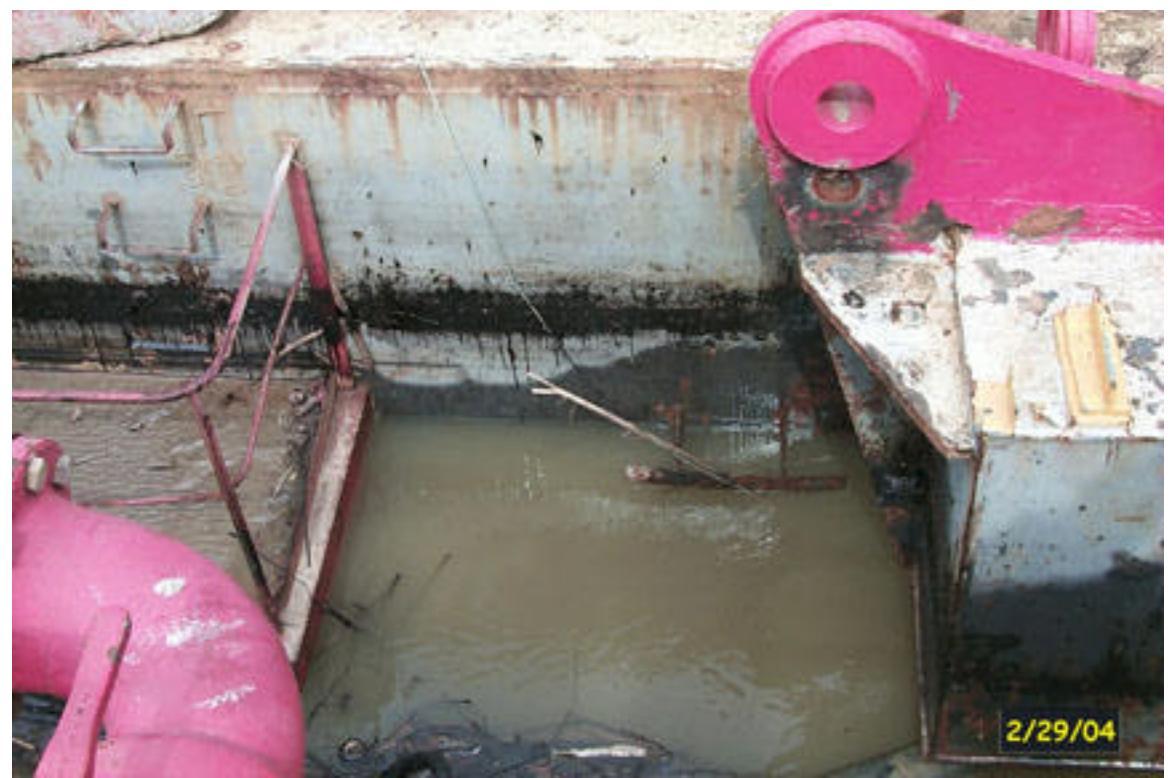
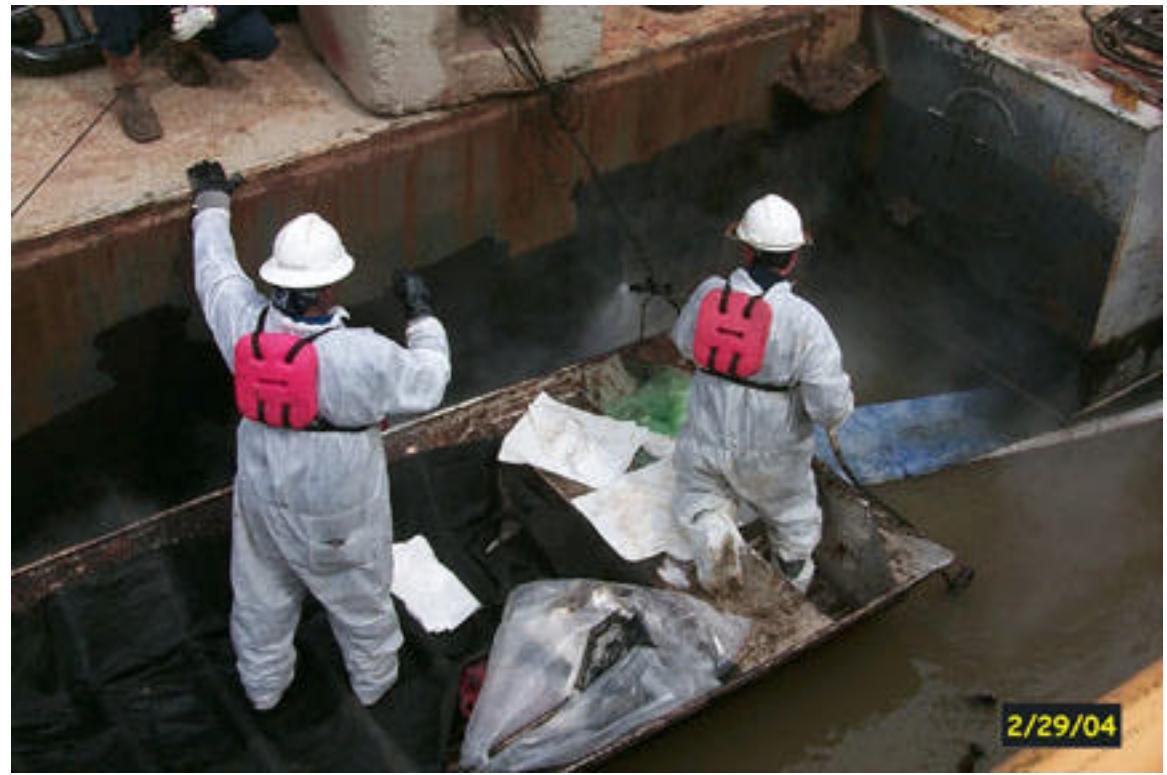
During the site visit, cleanup of a "bathtub ring" of oil coat on the floating dock was in progress using a high-pressure hot water wash system. The spill management team thought that all operations at the Avondale cleanup site would be completed by Monday evening, 1 March. Additional cleanup might be requested by the site operator (landowner), but unless there are observations of sheens or visual oil contamination in the water, cleanup is nearly complete from a state and federal prospective. Attached photographs:

Photographs 7 and 8 are of the "bathtub ring" of oil coat and the current high pressure flushing operation.
