The OSSA II Pipeline Oil Spill: The Distribution of Oil, Cleanup Criteria, and Cleanup Operations

EDWARD H. OWENS^{†*} & TONY HENSHAW[‡]

An estimated 29,000 bbl of mixed crude oil and condensate were spilled on 30 January 2000 from the OSSA II pipeline, which was damaged during summer flood conditions, at the Río Desaguadero river crossing on the Bolivian Altiplano. The oil was deposited as far as 370 km downstream along a total of approximately 400 km of river channel banks, meander flood plains, and irrigation ditches, as well as on several hundred hectares of low-lying flood plain wetlands. The oil was transported over a large geographic area but was cleaned up successfully and rapidly, in three months, by a large response operation that involved more than 3600 people, including 3200 local laborers at the peak period, using manual cleanup

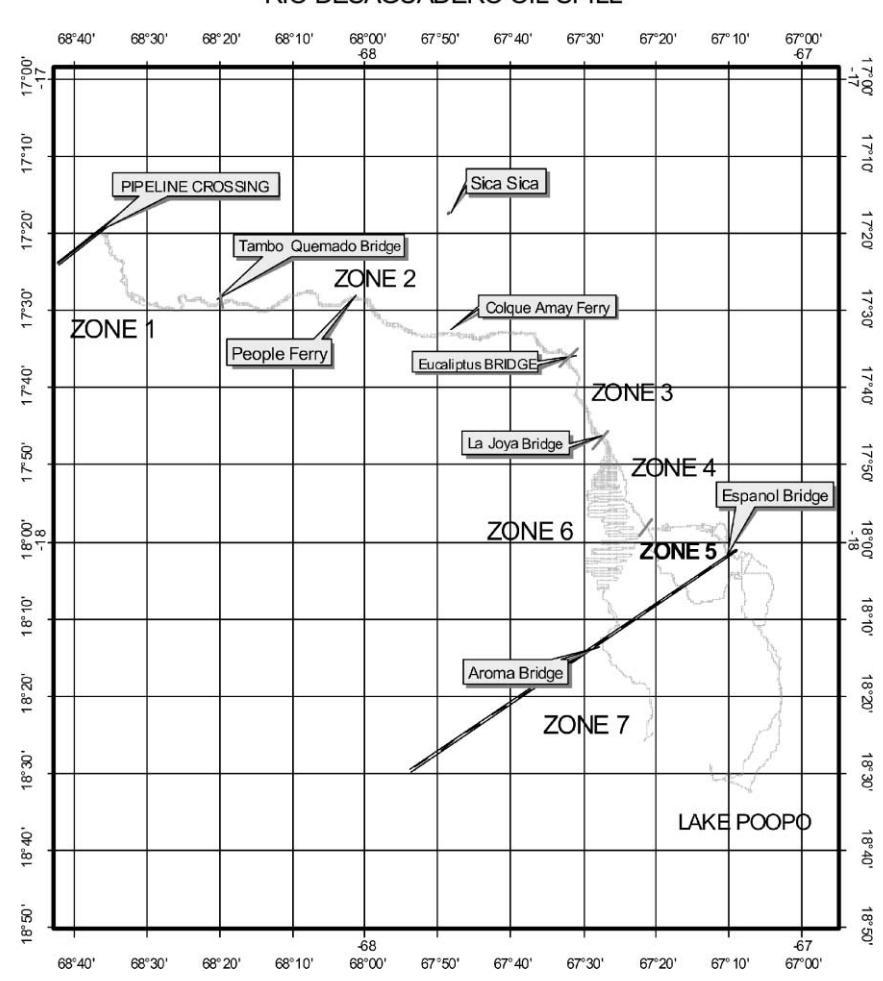
RIO DESAGUADERO OIL SPILL

Fig. 2 Operational zones in the affected area. The line southwest from the Espanol Bridge is an embankment with a road that marks the southern boundaries of Zones 5 and 6: the flood waters are channeled through culverts during the rainy season.

was initiated immediately and the affected area was divided into six operational zones (Fig. 2). A cleanup program using local labor was organized that peaked at a total of 3200 in March and details on the cleanup activities are provided in a series of internal project reports (e.g., Polaris, 2000a,b; Transredes, 2001). Extensive sampling was conducted to determine the risk from the oil residues and to monitor water and sediment quality throughout the affected area (Taylor *et al.*, in preparation). The majority of the cleanup was completed by the end of April 2000, but a second phase cleanup program to remove oiled vegetation was carried out through the winter months in Zone 6 to address perceived impacts to forage and grazing animals.

Below the pipeline crossing, the Río Desaguadero follows a single large channel for approximately 300 km (Zones 1–3) (Fig. 2, Table 3). In this section the river is confined to a single, wide, channel within which there are mixed reaches with many braided sections and numerous fine sand point bars, midchannel islands, and shoals. There are extensive flood plains on the meander bends, but elsewhere the channel has eroding cut banks that range up to several meters in height. In this upper section, variations in the flow conditions lead to flood-related and seasonal

The most distant surface oil from the source was located in Zone 7 (near $67^{\circ} 27'30''$ West; $18^{\circ} 14'00''$ South) and in Zone 5C (near $67^{\circ} 11'00''$ West; $18^{\circ} 14'30''$ South), approximately 350 and 370 km downstream respectively (Fig. 2).

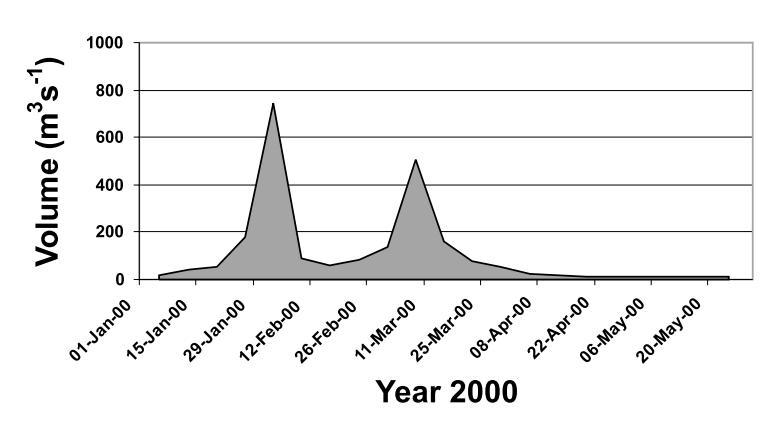
Fig. 3 Discharge of the Río Desaguadero at the Inti Raymi mine, La Joya, January-May, 2000 (see Table 2) (Columba, pers. comm.).

At Inti Raymi, just below Puente La Joya, the measured mean annual flow is on the order of 90 m³ s⁻¹. The flow is highly seasonal and mirrors the precipitation seasons (Table 1 and Fig. 3). During the winter in the driest seasons the flow rates can decrease to less than 4 m³ s⁻¹. At the time of the spill, the river was in a high flow condition, with a measured discharge at Inti Raymi of 740 m³ s⁻¹ (Fig. 3) and flow rates over 1.5 m s⁻¹ (Table 2). Measured discharges at Inti Raymi were less than 20 m³ s⁻¹ before and after the 2000 flood season. By comparison, during January and February 2001 the peak measured discharge was 688 m³ s⁻¹ (Engr. Columba, Inti Raymi mine, pers. comm., April 2001).

A second high-water level associated with high runoff in early March (Fig. 3) caused some of the stranded oil to be buried by a clean layer of silt.

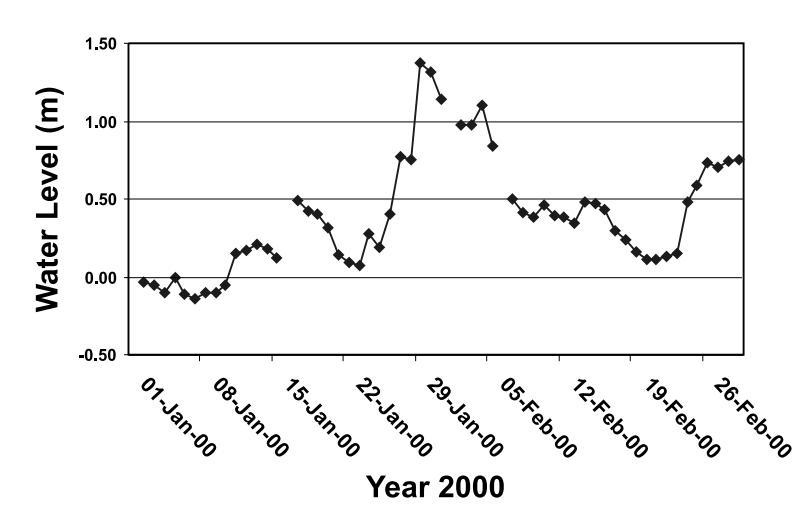
Fig. 4 Measured water levels of the Río Desaguadero at the Inti Raymi mine, La Joya, January-February, 2000 (Columba, pers. comm.).

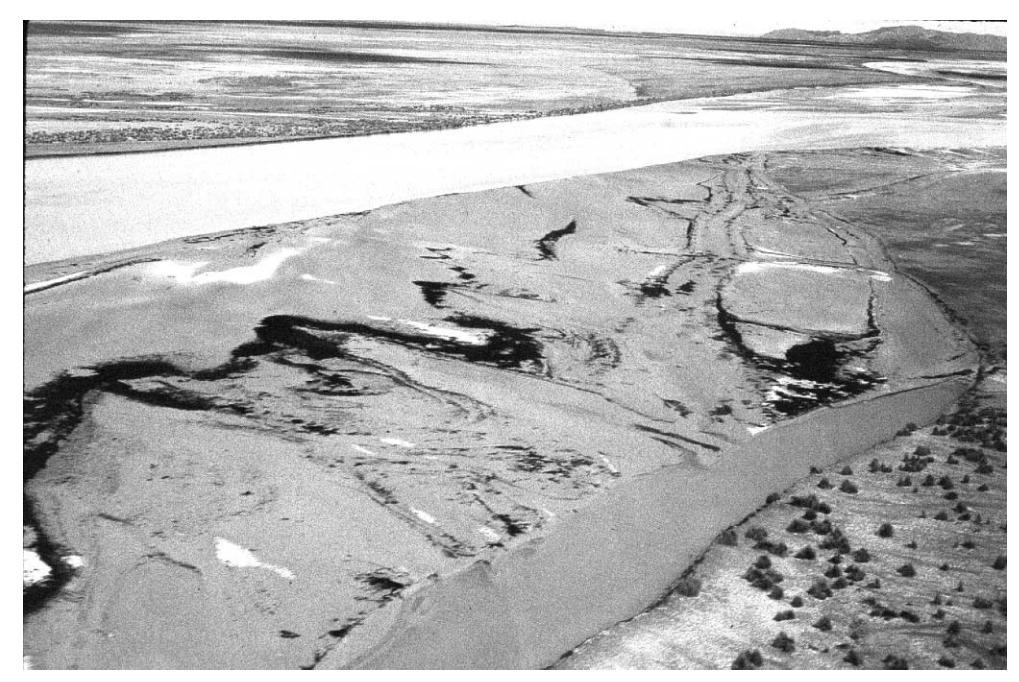
Fig. 5 Aerial view to the west, from approximately 150 m above the ground, of stranded oil on exposed sand bars in Zone 3 on 25 February, 2000. The main channel of the Desaguadero is in upper frame and during the flood stage the water extended to the vegetated area in the lower right.

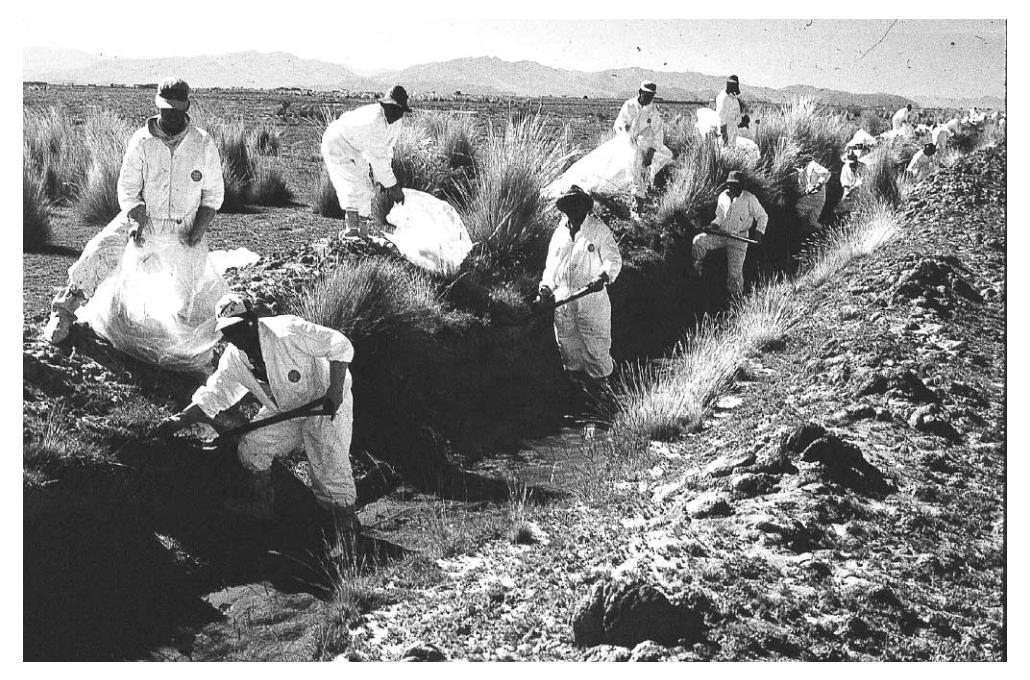
Fig. 6 Cleanup of irrigation canals in Zone 5C, 17 March 2000.

The canals, ditches and watering holes that had observed oil were cleaned (Fig. 6) and locations that were suspected to have oil were sampled. After cleanup the sites were re-sampled (Taylor *et al.*, in preparation).
