## Tanker and Barge Collision in New Orleans, LA Update July 23, 1:00 p.m EDT

### **Situation Overview:**

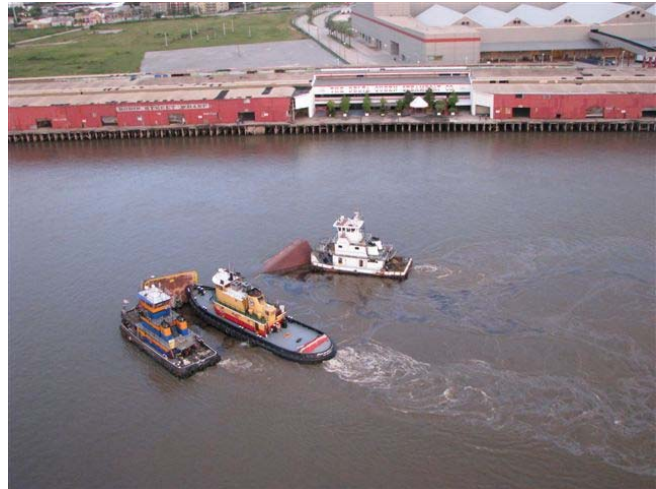
Tugs holding sections of the ruptured barge just upstream of the Crescent City Bridge. USCG Photo

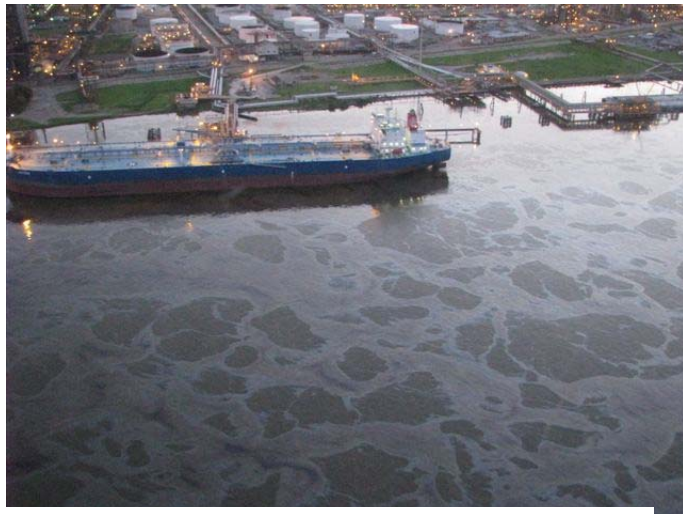
The USCG conducted an overflight of the river at first light (0730 CDT). At that time the barge was still leaking oil. Heavy concentrations of black oil was observed along the River Walk area along the West descending bank (French Quarter). At that time, approximately 14 miles of river had black oil and silver sheen with an estimated 90% coverage. The leading edge of the slick was at River Mile 80 (the collision was at RM 96), where the observers found black streamers about 20 meters long and 20 meters off both banks. This matched well with the initial trajectory prediction.

Silver sheen and black oil streamers. Vessel in background is not part of the incident. USCG Photo
